**Quality Coating -
The right solution for every location**

Latest Developments in the Prevention of Filiformcorrosion

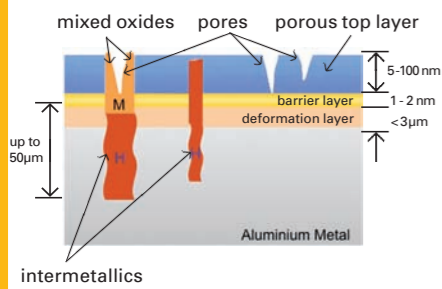
Pic. 3: Diagram of the natural oxide layer

At this point it seems to be sensible to reiterate the tasks of the pre-treatment process, however well known they might be. The natural oxide layer of Aluminium (shown as a diagram in image 3) is not suitable as a coating surface, as more often than not it is contaminated by foreign substances, which are preventative to the adhesion of the coating. As a result, the main purpose of the pre-treatment is to adequately prepare the surface to specification, to passivate the active metal and thereby to aid adhesion and assist in the prevention of corrosion.

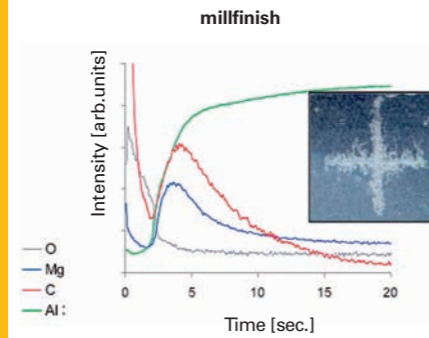
Pic. 4: GDOES – Analysis and surface image of rolled blank sheet, clear lacquered and tested at 80% rel. humidity and 40°C. *

The intermediate layer (Oxygen decreases whilst Aluminium increases) of the blank rolled sample (pic. 4) displays clusters of Magnesium and Carbon with corrosion testing resulting in Filiformcorrosion.

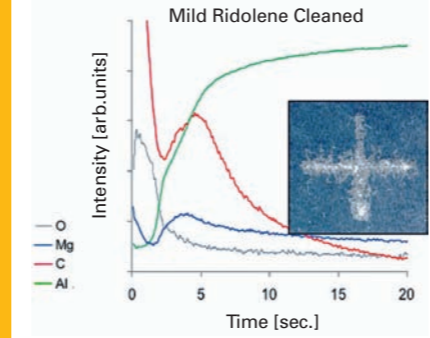
Pic. 5: GDOES – Analysis and surface image of mildly alkaline degreased sheet, clear lacquered and tested at 80% rel. humidity and 40°C. *

The mildly alkaline degreased sample (pic. 5) still shows traces of this intermediate layer of Magnesium and Carbon and once again corrosion testing does result in Filiformcorrosion. Only the alkaline etched sample (pic.6) that has undergone an acid finishing treatment (deoxidation) shows the complete removal of the intermediate layer and no signs of Filiformcorrosion after corrosion testing.

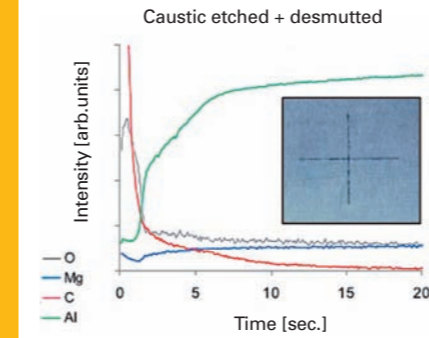
Pic. 6: GDOES – Analysis and surface image of etched and deoxidised sheet, clear lacquered and tested at 80% rel. humidity and 40°C. *

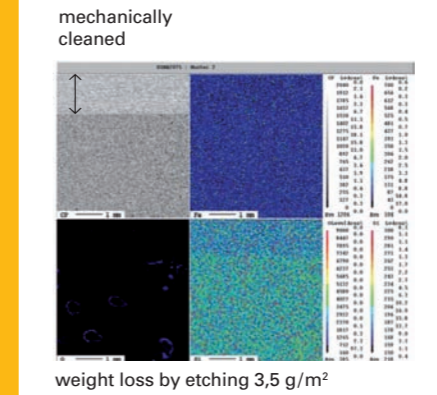
Pic. 7: Distribution image showing the elements of oxygen, iron, silicon in a profile section after etching with weight loss of 3,5 g/m².

This behaviour is documented in pics 7 and 8 on extruded profiles of alloy AlMgSi (EN AW 6060). The images show the distribution of elements Iron (Fe), Oxygen(O) and Silicon (Si) measured with an electron beam micro probe and the relevant electron backscattering image (Cp). A part quantitative surface distribution of the elements is assessed in a wavelength dispersive x-ray analysis (WDX).

Pic. 7 shows the distribution of elements in a profile segment with a level of removal by etching of 3,5 g/m² whilst

the segment in pic 8 shows a removal of 1,05 g/m². Pic 7 shows an increase in the distribution of Silicon on the surface in comparison to the polished area (top quarter of the individual image), whilst pic 8 clearly presents an even Si-distribution across the entire surface. One can therefore only conclude that specific and individual circumstances need to be considered.

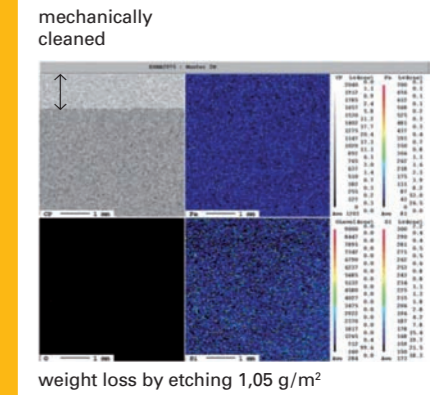
Pic. 8: Distribution image showing the elements of oxygen, iron, silicon in a profile section after etching with weight loss of 1,05 g/m².

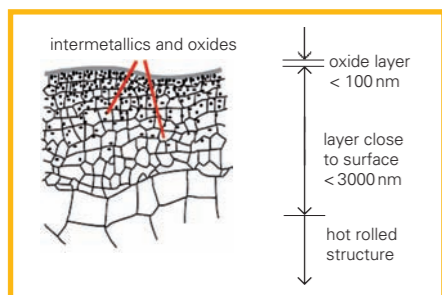
Pic. 2: Diagram of the deformation layer according to Fishkis and Lin (3)

Fishkis and Lin (3) have published a diagram of these sensitive surface areas (shown in pic 2), but the formation of micro-crystalline deformation layers is
